Mattole Estuary Monitoring Report May 2020

(based on updated structure and pool survey data collected in the summer of 2019) This monitoring was based on the following plan.

By Josh Madrone
Project Coordinator
Mattole Salmon Group
May 3, 2020

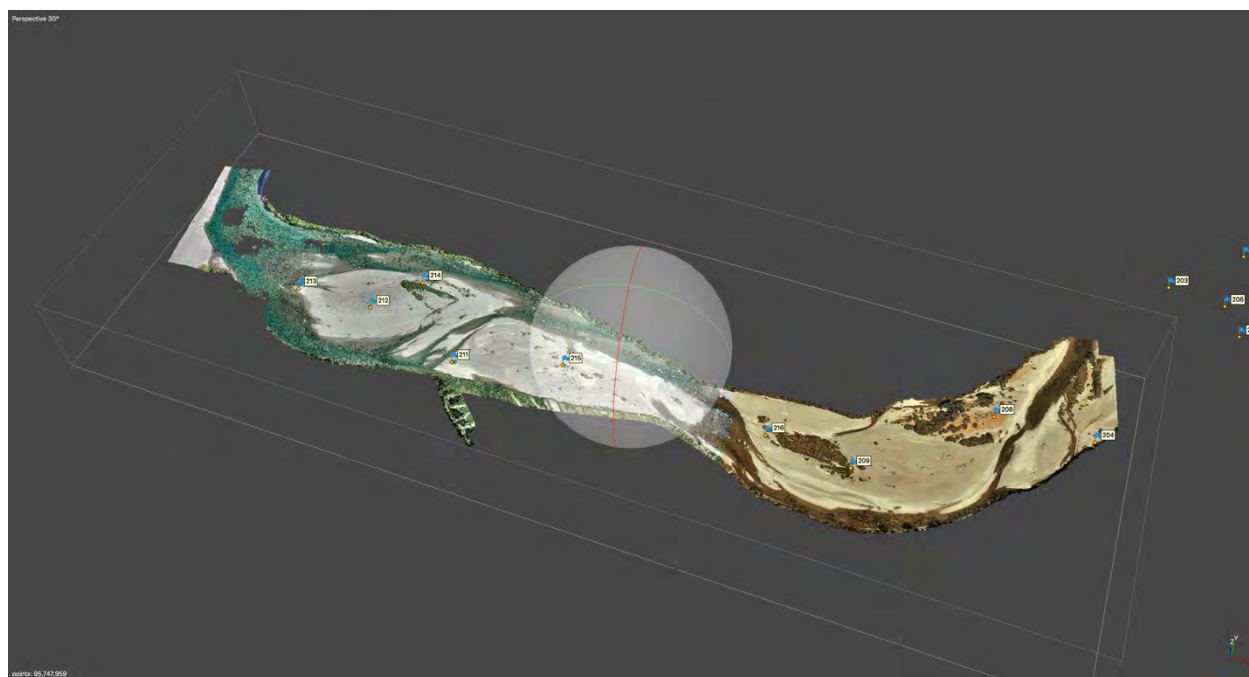
FIGURE 1 - PROCESSING AERIAL IMAGERY IN AGISOFT METASHAPEPRO

Photogrammetry is the science of obtaining reliable measurements from photographs and digital imagery. The 2019 aerial imagery was collected with an Unmanned Aerial Vehicle (UAV) – DJI Phantom 4 Pro v2 – with a 20 Megapixel camera, flying ~300 ft Above Ground Level (AGL). The resulting photos were processed in Agisoft MetashapePro v1.6.0 to create 3D spatial data to be used

in GIS applications. The two primary outputs that were created and exported are a georeferenced orthomosaic, commonly used in geographic information systems (GIS) as a "map accurate" background image, and Digital Surface Model (DSM), which gives you the height of the objects that are on the surface of the earth. These files are saved in the most-GIS-compatible GeoTIFF format. Ground Control Points (GCP) were surveyed with RTK GPS by Connor Shae of USFWS, which were used in the reconstruction of the model, with a few saved for check points to measure the accuracy of the finished model.

Processing reports are available on the file server, which contain information about accuracy, cameras, ground control points, digital elevation model, sparse and dense point clouds, and orthomosaic.

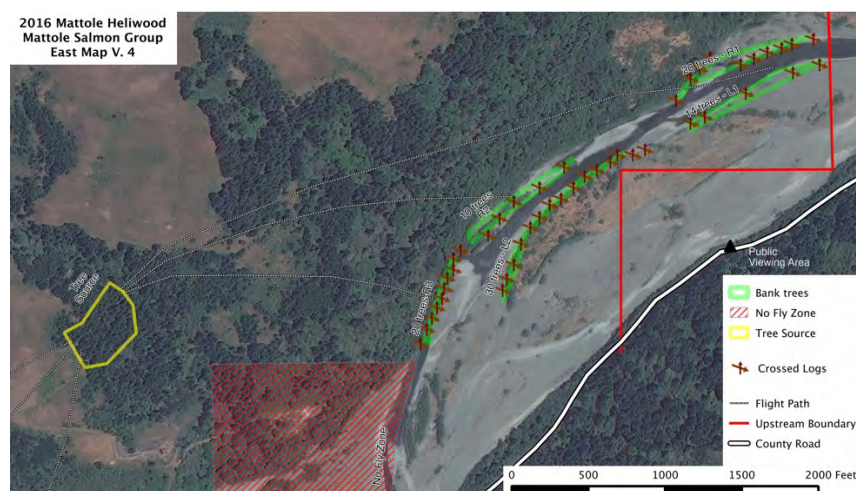
FIGURE 2 - 2016 HELIWOOD MAP, EAST SITES

The 2016 helicopter wood placement component for this 2016 work included the following numbers of whole trees placed:

A total of 103 pieces placed instream, at terrace margins, or on the right bank (nearly all were Whole-trees, with boles and integral root wads). Plus, approximately another 150 pieces were delivered to the south-side terrace -- to sites L-3 and L-4, located upstream from the 2013 project area -- and subsequently used for stream barbs (small to medium-sized trees, some without root wads). Trees were tipped on-slope with an excavator and placed in the river by helicopter. Total acres of riparian area treated was 20. Over 2000 15-foot long willow cuttings were planted in the deep trenched baffles.

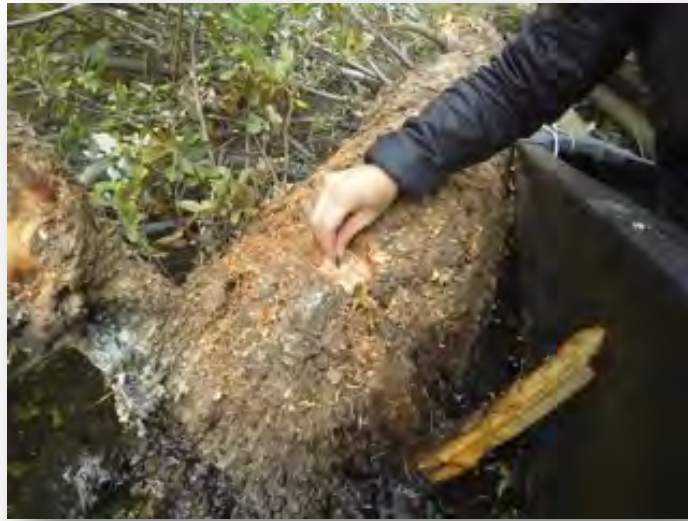
FIGURE 4 – A PASSIVE IDENTIFICATION TAG (PIT) TAG IS INSERTED INTO TREE 4' ABOVE ROOTWAD

After tree placement was complete, the Mattole Salmon Group implemented a monitoring program to answer the question, “Which trees moved, under what size flows, and where.” This monitoring program involved placing a Passive Identification Tag (PIT) into each whole tree. A hole was drilled with a cordless drill at 4’ above root wad. The hole was drilled towards the center of the log, and at a depth to put the tag ½ inch under the cambium. The tag was inserted into the tree (see figure 5). Silicone calk was used to seal the hole and secure the tag. Trees with greater than 16” diameter got two tags, on opposite sides of the tree. Additional information was collected about size (total length and diameter at breast height (dbh), species and complexity for each tree and associated with the trees individual number. Using a total station all trees were marked in their orientation on the landscape. The total station work gave us an as built map of the entire project site with one (1) foot contour intervals.

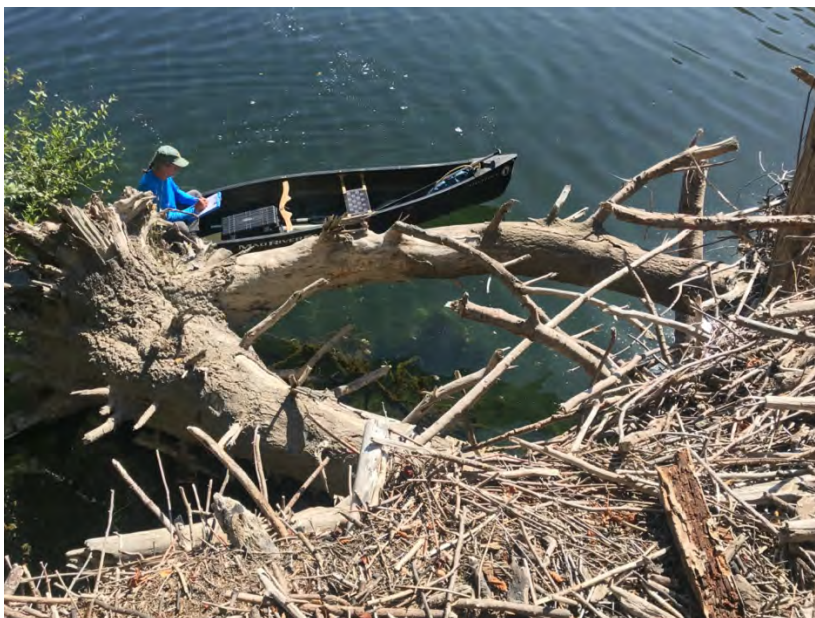
FIGURE 5 – COLLECTING POOL AND LWD DATA

This follows monitoring work done in 2014, summer 2017, and now again in summer 2019. The 2019 survey was completed by Josh Madrone and Sungnome Madrone. A drone was used for topographic and bathymetric information combined with ground surveys of pool length, width, and depths, and locations of large wood/whole trees.
